# Coleman Creek for Cape Meares Community Association, Coleman Creek, Tillamook Co., OR

Mike Patterson  
Celata Research Associates

February 2023

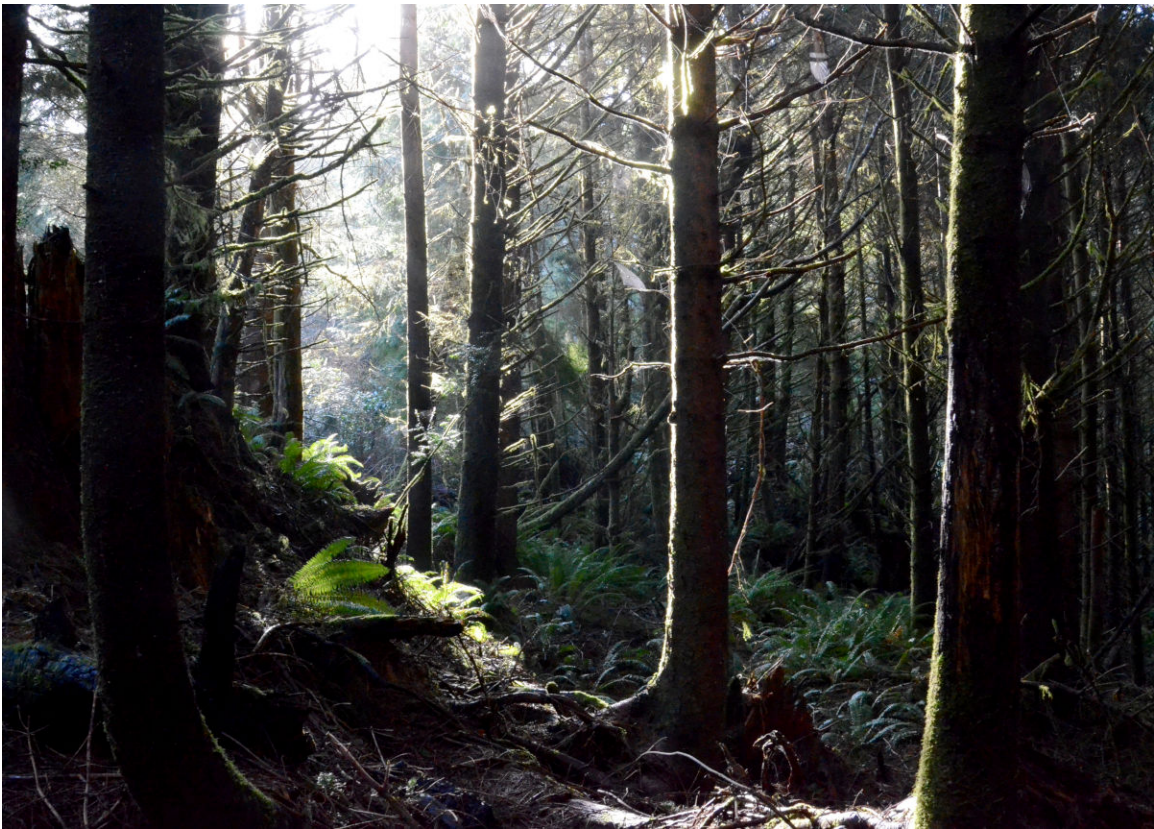
Photo01: Dominant plant species are primarily densely planted even-aged Sitka Spruce and Western Hemlock with a poorly structured understory dominated by Western Swordfern.

**DENSE YOUNG EVEN-AGED FORESTS:** Much of the property has been logged sometime in the last 40-50 years. Aerial images indicate most of the site was clearcut between 1984 and 1990. Sitka Spruce and Western Hemlock appear to have been planted after the cut and have produced a dense even-age forest. These young, closely planted forests are too dense to allow for an understory of shrub and forb species and typically show lower diversity for both forest plant species and associated animal species. The remedy for this is thinning and selective day-lighting to break up what is, essentially a monoculture. The introduction of Red Alder and other native hardwood species should be encouraged. Material from thinning should be left *in situ* to increase woody debris and mycorrhizal activity to stabilize soil movement and improve stream clarity.

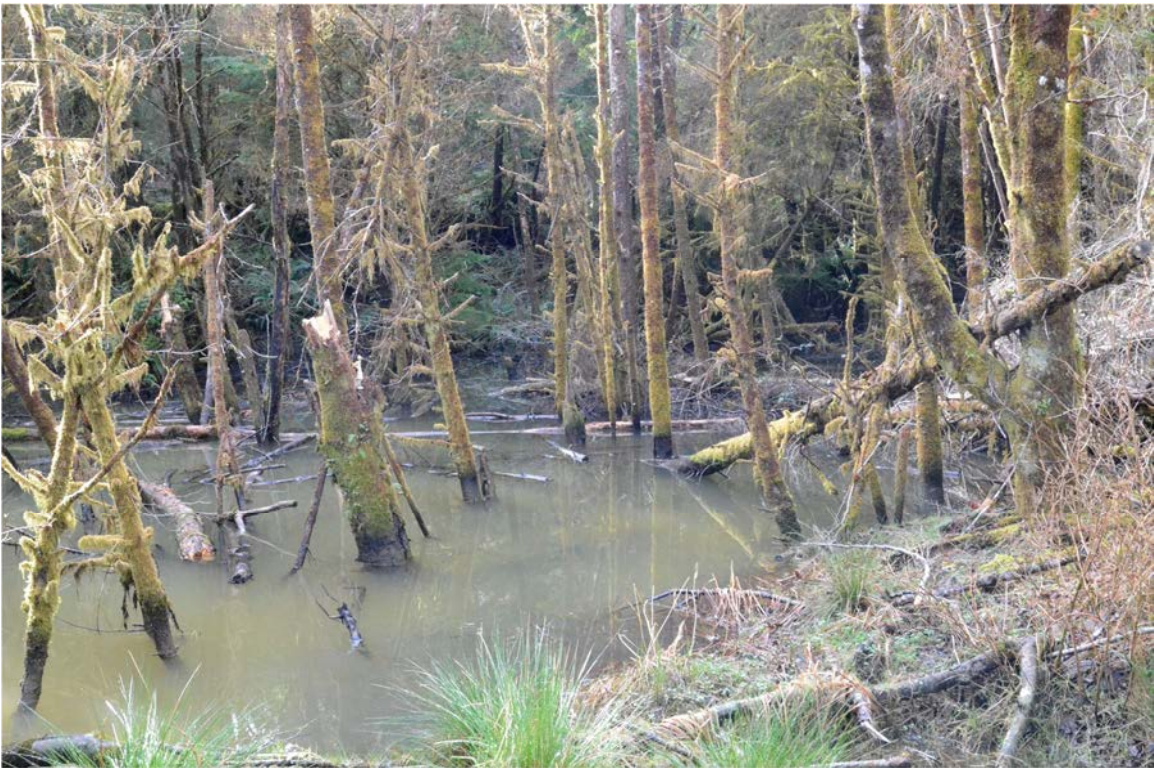
Photo02: Water has impounded in several areas along the southern edge of the property associated with a large landslide that occurred in 2017.

Stream condition – Both large streams running through the property, as well as the ephemeral tributaries, show considerable impact from past forest harvesting practices and road building. Most streambeds lack woody debris and terracing resulting in erosion and siltation from unrestricted flow. The large landslide event along the southern edge of the property is also a likely artifact of effects of forest harvesting practices and road building on the waterflow dynamics of the site.

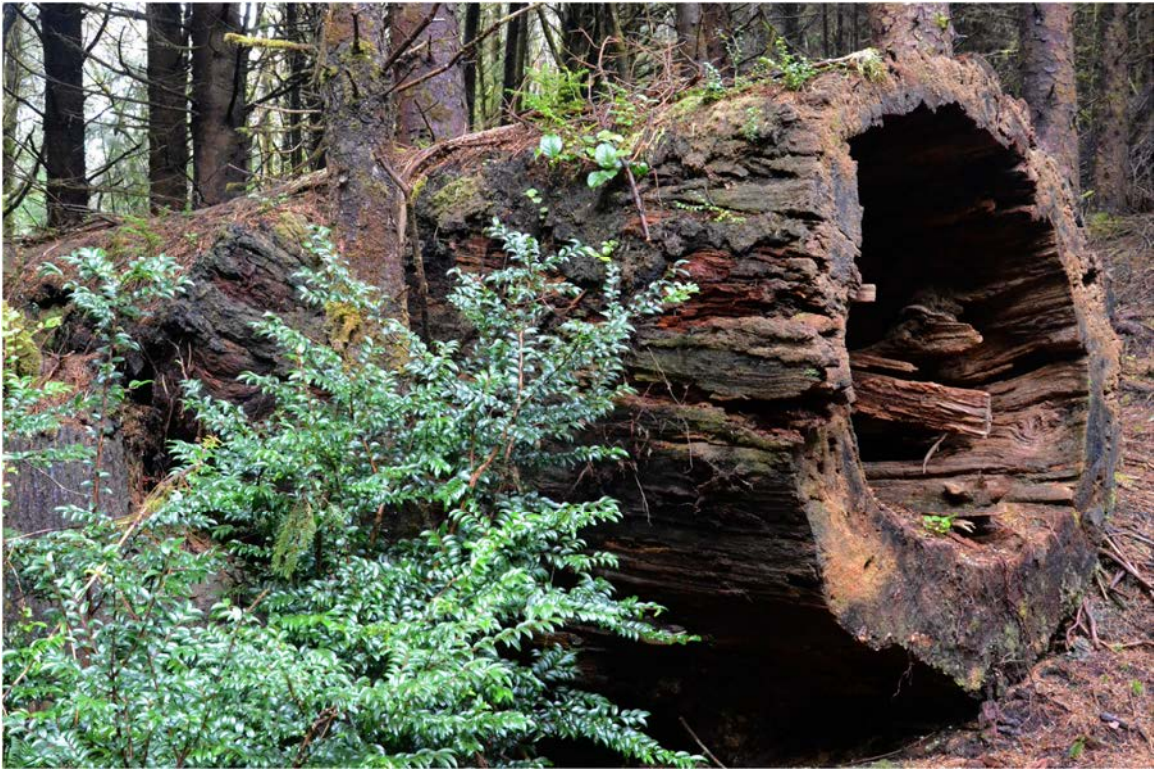
Photo03: Stumps and rejected old growth logs from one of the early harvests can still be found scattered throughout the understory.

Forest composition – The property is entirely forested and most of the forested areas are a mix of young (30- to 50-year-old) Sitka Spruce, Western Hemlock, and Red Alder, much of it very densely spaced as is typical of systems that have a history of recent commercial logging followed by re-planting. Remnant stumps from the original old-growth forest are scattered throughout the property. These average between 6 and 10 feet in diameter.

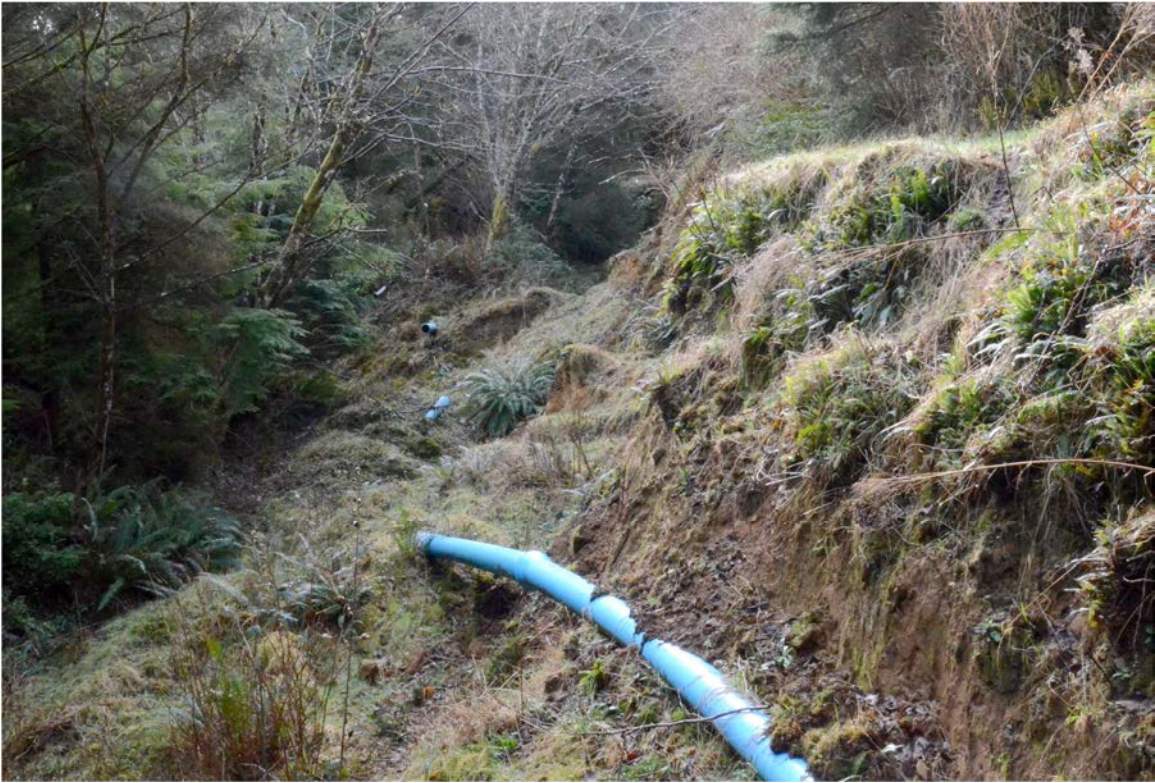
Photo05: There is a 350-meter long landslide along the access road to the former water tower for the Cape Meares water supply.

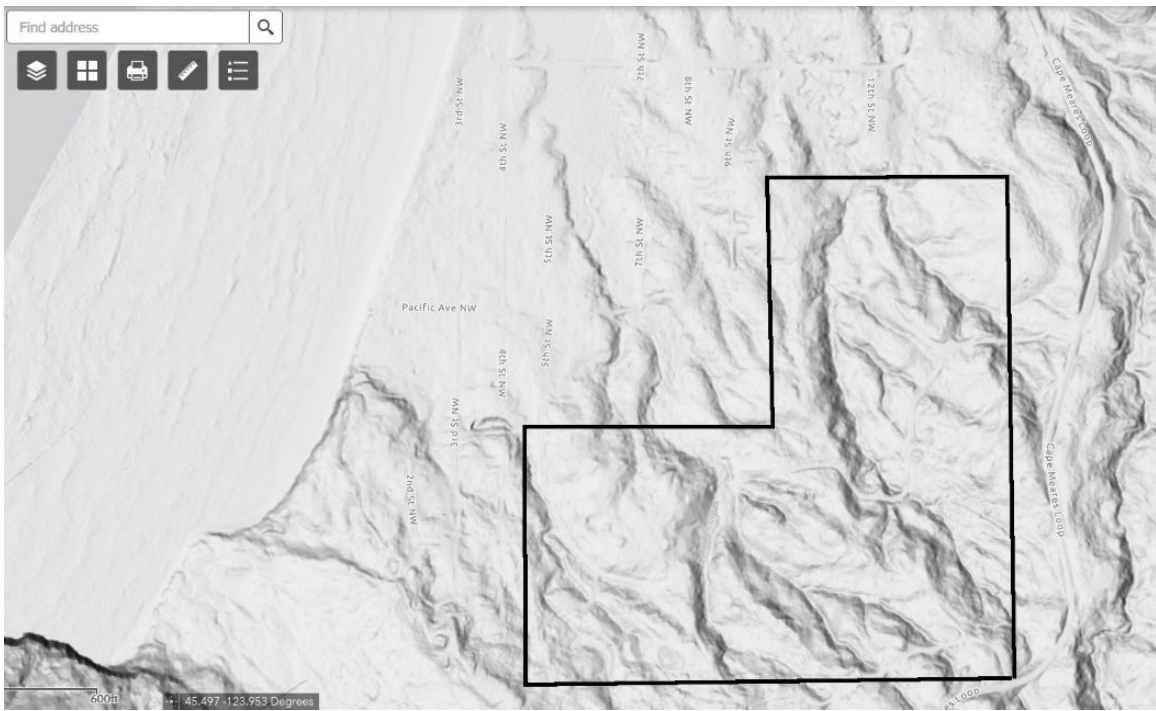
Map02: Bare Earth LIDAR showing physical terrain of proposed acquisition.

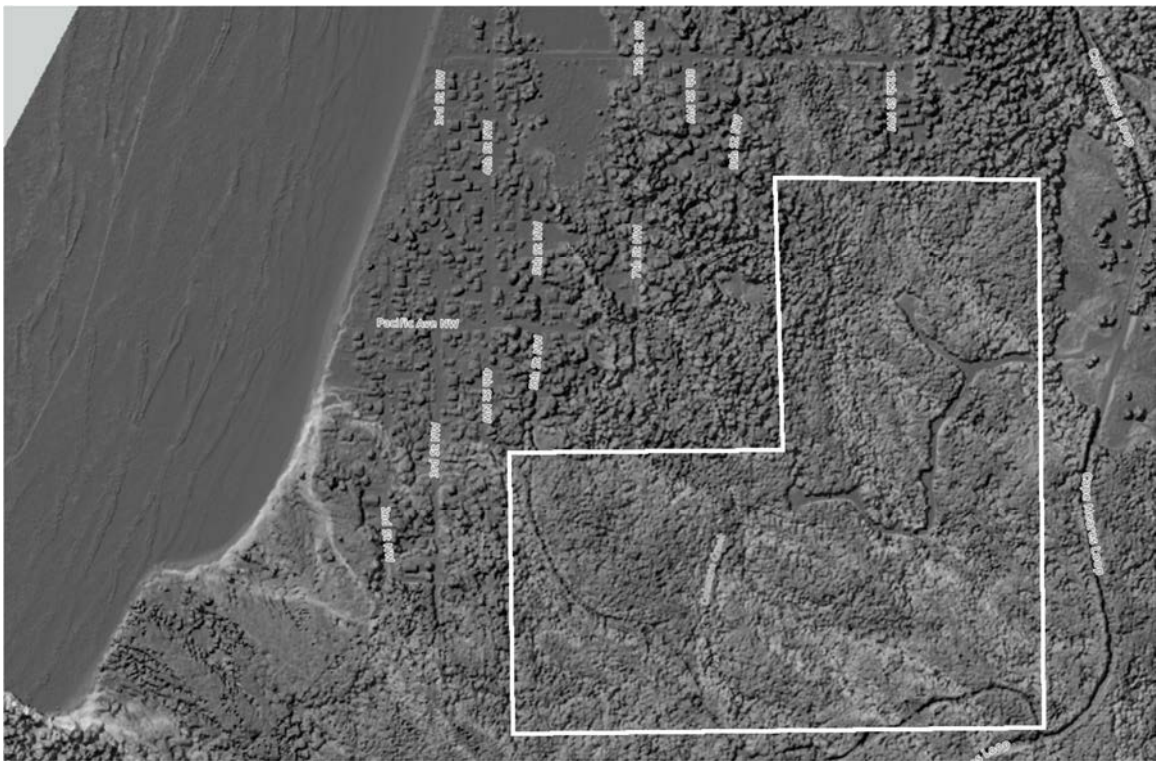
Map03: Highest hit LIDAR image of the proposed acquisition showing the distribution of young, even-age forests on the site compared to more mixed age stands outside the property boundaries.

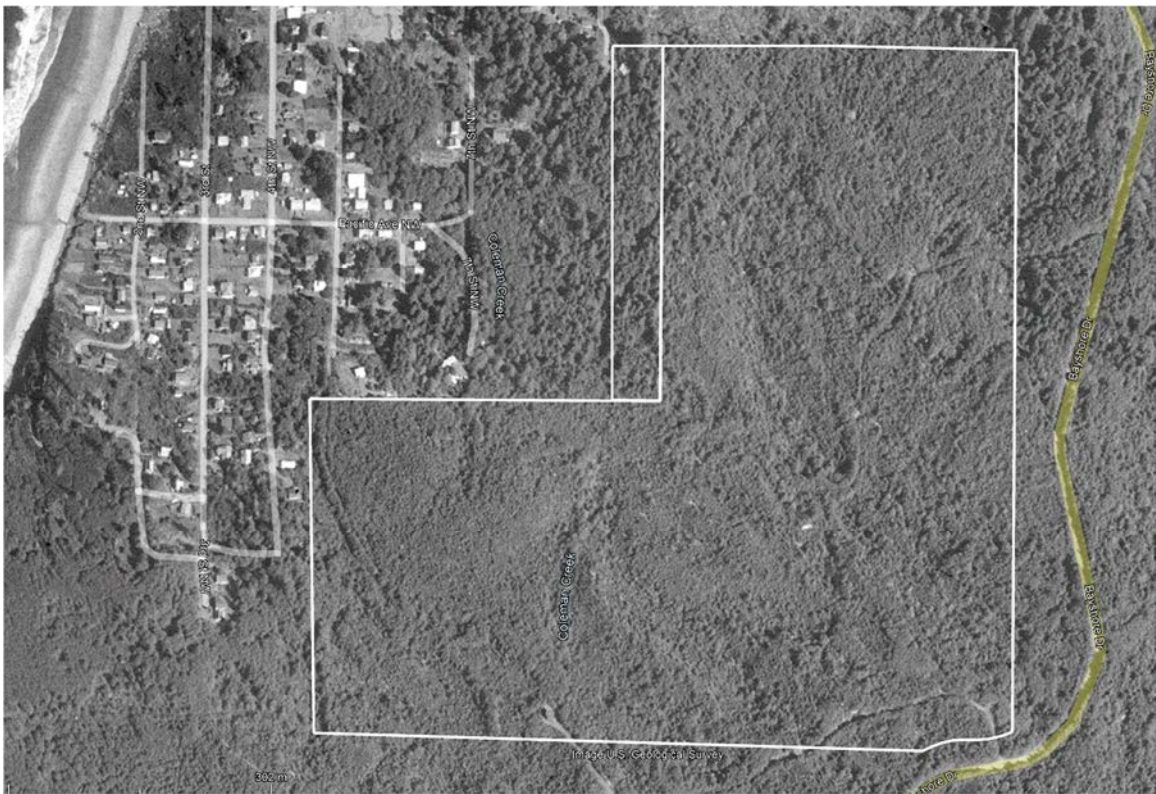
Map04: Google Earth photo from 9/3/1994 shows the area with very young recently planted trees in southwestern third and somewhat older trees in the eastern part.

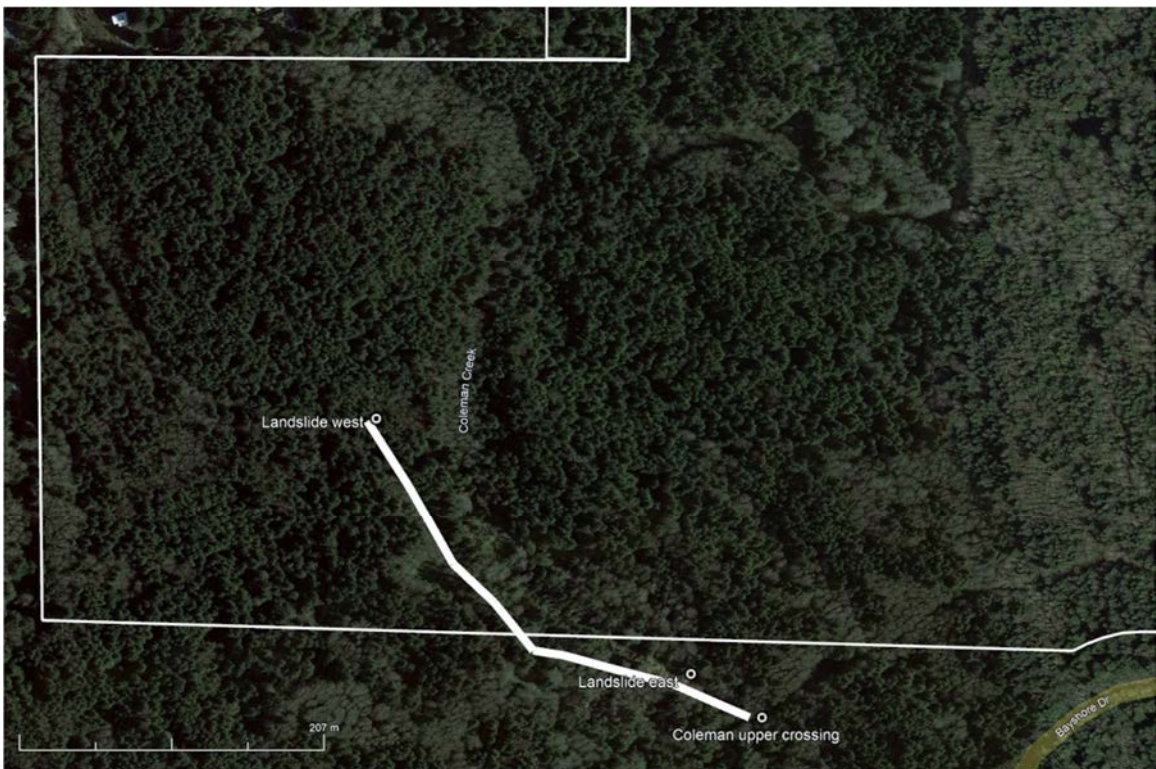
Map05: GPS track of landslide location. Length approximately 350 meters.
